**Flood Control Project Maintenance
Levee Inspections
LMA District Cover Sheet
Spring 2010 Levee Inspection Results**

Sacramento Maintenance Yard Putah Creek

Levee Inspection Report By Mile - Spring 2010

Waterway						Bank	Unit Miles	Inspection Start/End	Inspector	
Unit No. 01 Putah Creek or North Levee						Left	8.99	04/06/2010 04/06/2010	Herman Phillips	
LMR No	Levee Mile		Category	Item	Location	Rating	Action/Comment	GPS Latitude/Longitude		Issue No. Photo
	Start	End						Start	End	
1	0.03	5.97	Earthen Levee	Vegetation	WS	M	Control annual grass and weeds on the levee slopes and easements.	38.523277 ° -121.631438 °	38.518472 ° -121.732990 °	1 Y
2	0.03	0.28	Earthen Levee	Vegetation	LS	M	Control annual grass and weeds on the levee slopes and easements.	38.523238 ° -121.631447 °	38.520208 ° -121.633342 °	6
3	0.27	0.34	Earthen Levee	Encroachments	LS	PO	Landscaping	38.520305 ° -121.633168 °	38.520000 ° -121.634358 °	2
4	0.29	0.29	Earthen Levee	Encroachments	LS	PO	Buildings	38.520177 ° -121.633528 °	38.520177 ° -121.633530 °	3
5	0.30	5.97	Earthen Levee	Vegetation	LS	M	Control annual grass and weeds on the levee slopes and easements.	38.520052 ° -121.633775 °	38.518473 ° -121.732988 °

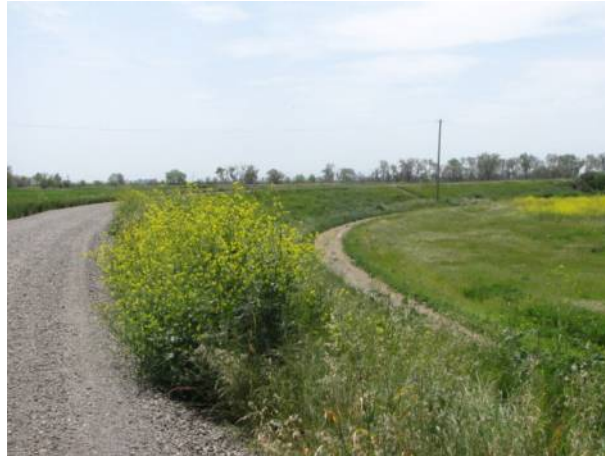
phillips_s_20100707_158.jpg

Levee Mile Report Line	1
Start Levee Mile	0.03
End Levee Mile	5.97
Location	Water Side
Category	Earthen Levee
Item	Vegetation

Looking downstream on land side unit 1 Putah Creek. District will have this mowed later in the spring.

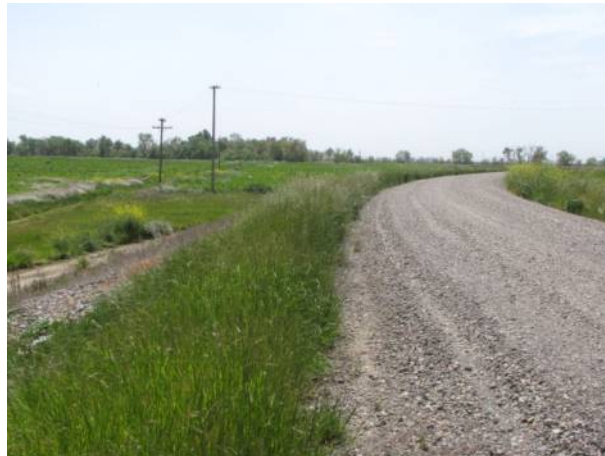
phillips_s_20100707_159.jpg

Levee Mile Report Line	1
Start Levee Mile	0.03
End Levee Mile	5.97
Location	Water Side
Category	Earthen Levee
Item	Vegetation

Looking downstream on water side levee mile 0.024 Typical view of Unit 1 before mowing.

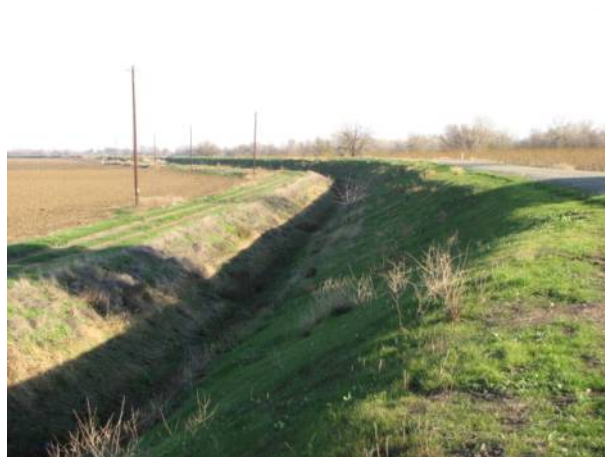
phillips_s_20100316_024.jpg

Levee Mile Report Line	7
Start Levee Mile	1.55
End Levee Mile	2.72
Location	Land Side
Category	Earthen Levee
Item	Encroachments

This ditch is located within the 10-foot easement and has been at this location for several years.

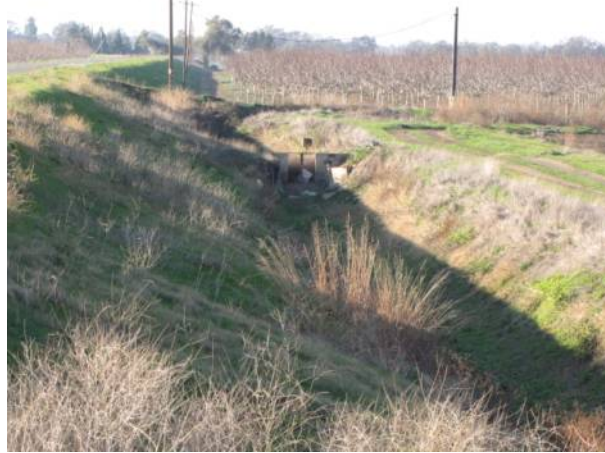
phillips_s_20100316_025.jpg

Levee Mile Report Line	7
Start Levee Mile	1.55
End Levee Mile	2.72
Location	Land Side
Category	Earthen Levee
Item	Encroachments

Another view of ditch looking downstream landward.

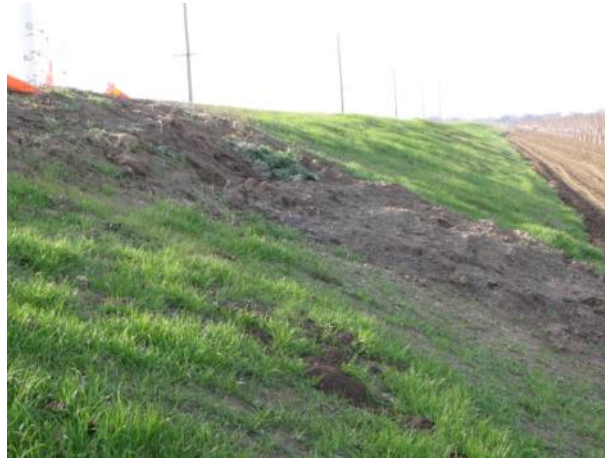
phillips_s_20100316_026.jpg

Levee Mile Report Line	5
Start Levee Mile	1.09
End Levee Mile	1.10
Location	Water Side
Category	Earthen Levee
Item	Erosion / Bank Caving

Photo shows partial repair of slope damage.

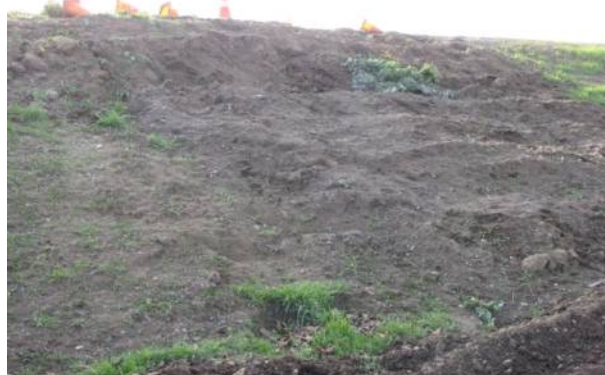
phillips_s_20100316_027.jpg

Levee Mile Report Line	5
Start Levee Mile	1.09
End Levee Mile	1.10
Location	Water Side
Category	Earthen Levee
Item	Erosion / Bank Caving

slope damage some repairs made. Proper repair need to be done at this site with compaction test to verify compaction.

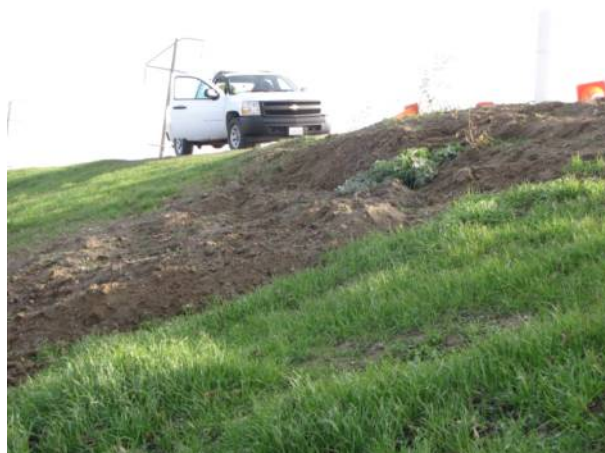
phillips_s_20100316_028.jpg

Levee Mile Report Line	5
Start Levee Mile	1.09
End Levee Mile	1.10
Location	Water Side
Category	Earthen Levee
Item	Erosion / Bank Caving

Another view standing on toe of slope looking upstream.

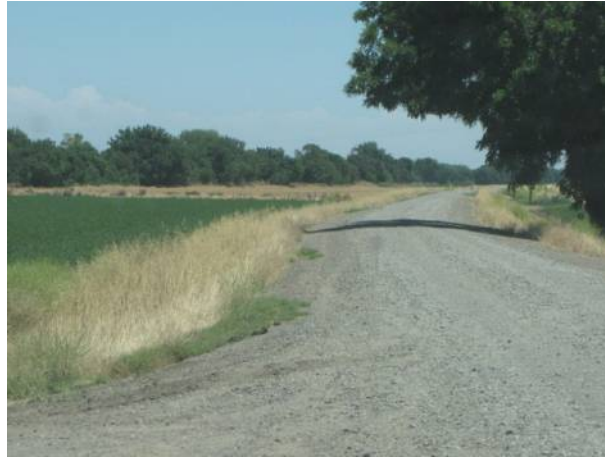
phillips_s_20100707_157.jpg

Levee Mile Report Line	8
Start Levee Mile	5.69
End Levee Mile	5.69
Location	Land Side
Category	Earthen Levee
Item	Vegetation

Looking upstream from old Davis road unit 2.
